Isis Gasworks Footbridge Assessment Report

Doc. Ref. 8019146-8486-AR-001

18 February 2021

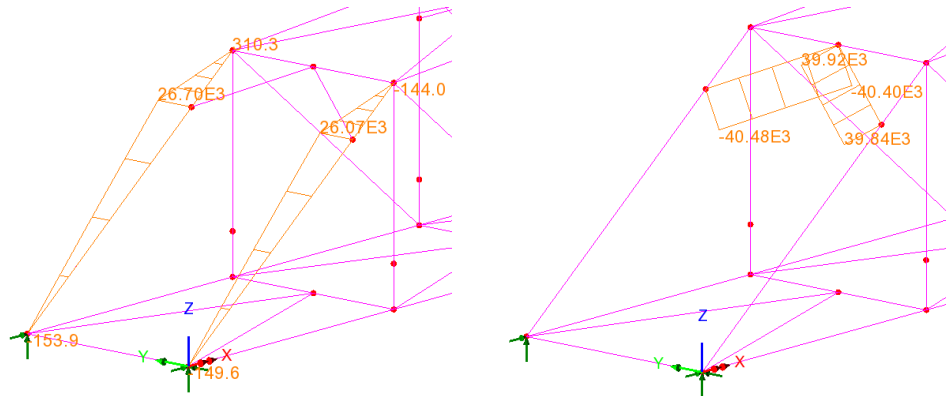
The utilisation of over 300% for members HR occurs at the load combination 2.2 (refer to section 3.3) and whilst the deck of the structure is loaded asymmetrically, and the side winds loads are applied. The structure behaves in such was that even relatively small wind loads with asymmetrical vertical loads are inducing some significant axial forces in the arched bracings at the end bays of the truss, which push the truss top chord sideways, which results in moment M_y (M_z in LUSAS) appearing. In absolute values, the total moment M_y is approx. 26.7 kNm, when all loads are factored, see Figure 7.1.

Figure 7.1 – Moment M_y (M_z in LUSAS) in member HR (left) and axial forces in arched (modelled as straight) bracings (right)

The capacity of the steel truss could be improved by introducing additional stiffeners or connections to the truss members, which would improve the individual angles' buckling capacity, but this would have to be combined with re-painting of the structure. The re-painting works are likely to require significant temporary works to prevent paint polluting the river underneath since there was lead found in paint (refer to 2018 IfA report), which is challenging due to the river navigation. Individual truss members strengthening and re-painting is likely not to be cost effective and the costs might be comparable to replacing the whole structure.

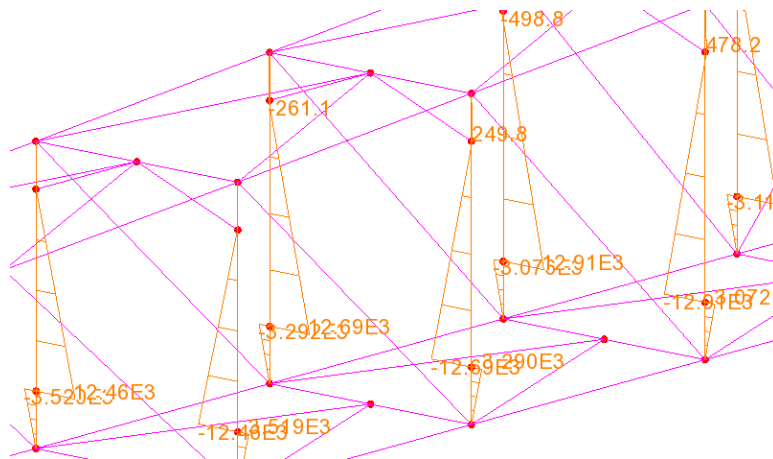
The utilisation of over 200% for the truss vertical members is due to the eccentricity of the applied vertical loads, which are causing the moment to appear in the vertical members, refer to section 3.4.1. This result is consistent for all of the vertical members (see Figure and appears at the load combination 2.1, when the vertical wind load acting on the deck is applied, which, in combination with other vertical loads that cause moment due to eccentricity such as bison planks self-weight, surfacing, etc. cause the worst-case moment M_y (M_z in LUSAS). The absolute value of this moment is approx. 12.9 kNm.

Figure 7.2 – Moment M_y (M_z in LUSAS) in truss vertical members

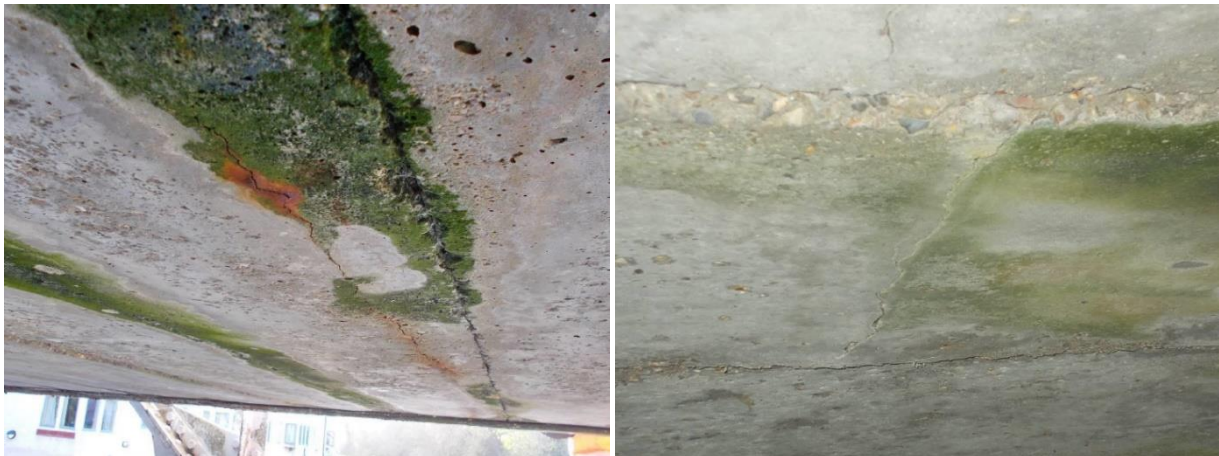
Both the assessment and the check suggest that Bison planks have sufficient capacity, assuming the condition factor F_c of 1.0; however, the planks were found to be in poor condition during the 2018 IfA, but a condition factor could not be easily applied to any of the planks. Some planks, as shown in Figure 7.3, have cracked along the longitudinal axis of the plank (bridge transverse axis). It is unclear how the plank is still intact, but it is possible that this is due to the arching action of the top flange of the hollow core plank and potentially due to the bond between the concrete infill and the planks, which act as an additional support for the planks in along their longitudinal axes not allowing the planks to fall through. Other defects, such as cracking in the plank transverse direction (bridge longitudinal direction) should not significantly affect the plank's capacity, but may have an adverse effect on durability which could lead to a reduction in capacity in the future.

Figure 7.3 – Cracking along the plank longitudinal axis along the reinforcement bar with corrosion staining (left) and plank cracking along its transverse axis showing some deflection of concrete (right)

The Bison planks, which provide the walking surface on the bridge, were found to have sufficient capacity, but only assuming the condition factor of 1.0. In reality, the planks are showing signs of significant deterioration and based on the defects such as significant deflection at the plank midspan and cracking along the plank length, the planks are deemed to be unsafe. It is also worth noting that the plank geometry was adopted from a textbook and the exact details of the planks are unknown.

The Bison type planks are likely to be difficult or impossible to repair and uncertainties with regard to the details of the planks mean that replacement of the deck planks would be highly favourable. Again, the replacement would require significant temporary works to prevent debris polluting the watercourse below.
