BUILDING DESCRIPTION

OXFORD HEET CASE STUDY 4: 6 NELSON STREET, JERICHO, OXFORD

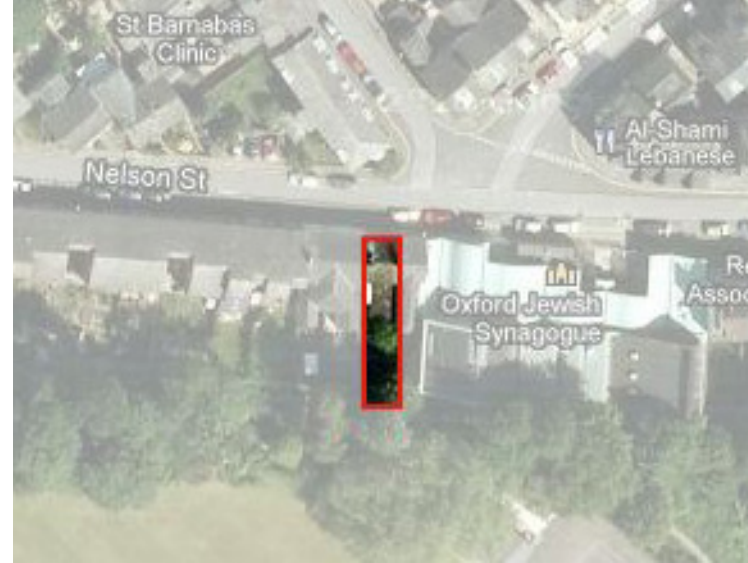
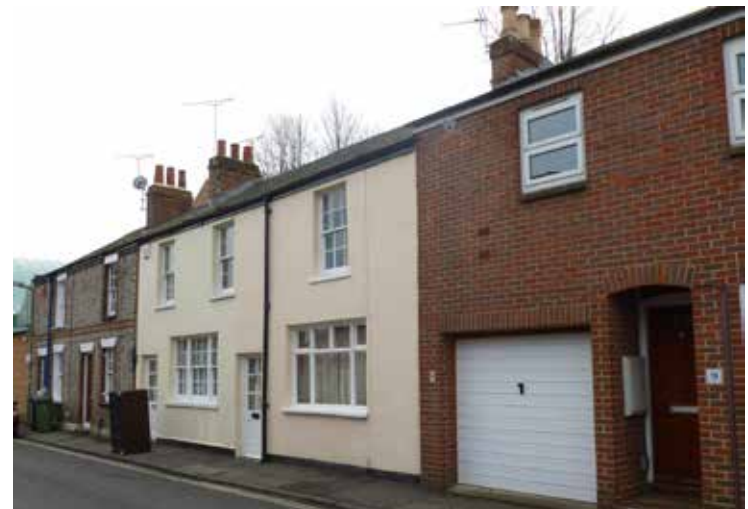
A traditional 'two up two down' terrace house within the Jericho Conservation Area, subject to an article 4 direction that curtails householder permitted development rights. It benefits from a later single storey extension and covered passage to the rear

The main building has uninsulated solid brick walls, topped by a slate covered roof with loft insulation. The front elevation has salt glazed headers, red brick surrounds to windows and the door, and a string course at first floor level. A chemical damp proof course has been injected but the wall remains damp at low level internally. The rear walls are rendered with a portland cement mixed and painted; and are also damp inside. The single storey extension is of cavity blockwork construction with an uninsulated lean-to roof.
